# Troubleshooting Exterior Masonry Walls

by Michael Gurevich

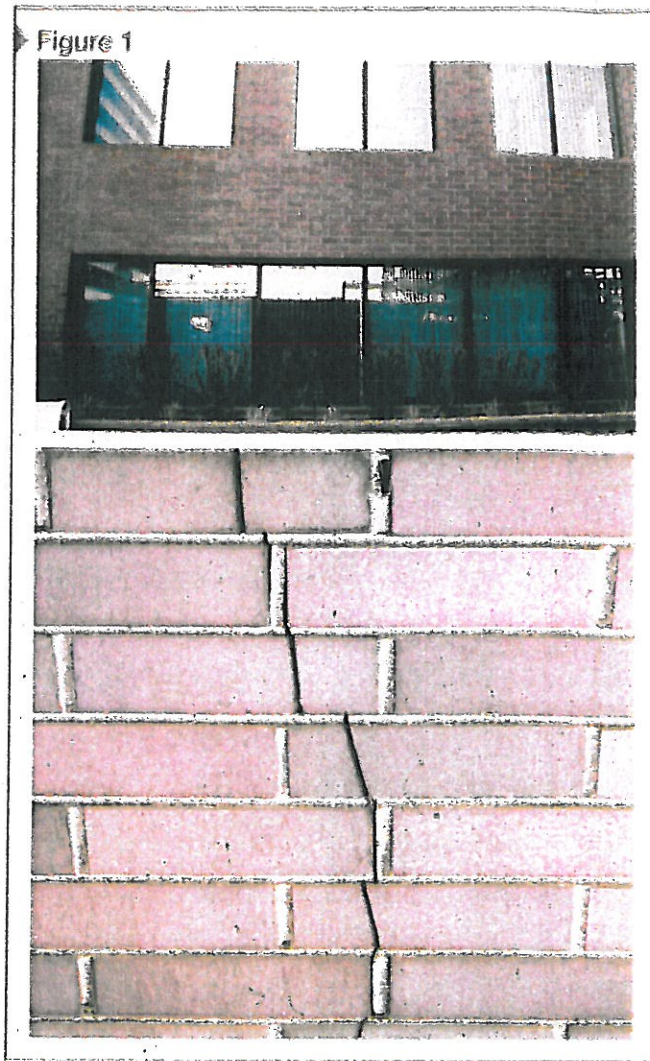
In Figure 1, a vertical crack had developed in the brick veneer in the middle of the large first-floor window. It started at the window head shelf angle as a wide, open crack, and had disappeared as a hairline crack above. This serves as a perfect example of the spandrel beam excessive deflection, which was translated into the brick veneer as the vertical crack.

A vertical crack developed in the brick veneer in the middle of this large, first-floor window. It began at the window head shelf angle as a wide, open crack, and disappears into a hairline above.

The problem is this building was designed in the early 1980s, when spandrel beam deflection had limits of  $L/360$ . To fix this problem, one must reinforce the spandrel beam, which would be an expensive proposition. Another option would be to treat the crack as a movement joint, which means to brace the brick veneer on each side with masonry restoration anchors before sealing the fissure.

Another option would be to reinforce the brick veneer with helical stainless steel rods—a technique popular in the United Kingdom with landmark building renovations. Horizontal mortar joints should be raked for a minimum depth of 25 mm (1 in.), and be extended for about 406 mm (16 in.) on each side of the crack. The rods should be embedded into the raked joint with a soft grout; they should be located every three to six brick courses apart to reinforce the veneer.

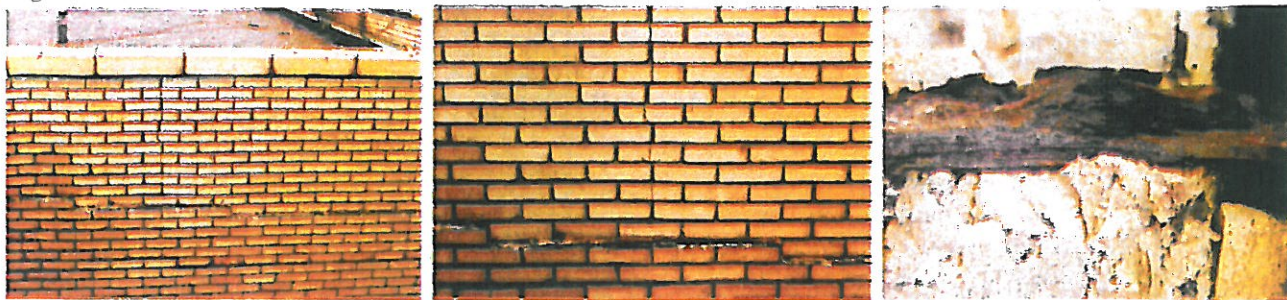
In Figure 2 (page 42), one can see the horizontal crack in the parapet brick wall mortar joints at the roof level with approximately 6.4 to 9.5-mm ( $\frac{1}{4}$  to  $\frac{3}{8}$ -in.) vertical displacement in the crack. In this case, the author observed a vertical crack, which started as a hairline at the horizontal crack location, and was wide open at the top of the parapet wall. It looks as if some forces had pushed brick up from the horizontal crack location to the top of the wall. Rust had most likely developed at the top of the steel spandrel beam.

This author's team opened the wall to expose the top of the steel beam, and observed the rust—which had delaminated and expanded up to 9.5 mm—built up atop the beam. Steel beam rust could expand up to 10 times, creating tremendous forces, which pushed the masonry wall up—this created horizontal and vertical cracks in the masonry walls.

This horizontal crack in the parapet brick wall mortar joints at the roof level resulted in 6.4 to 8.5 mm ( $\frac{1}{4}$  to  $\frac{3}{8}$  in.) vertical displacement

This is not, it must be made clear, a 'masonry wall problem.' When this building was constructed in the 1920s, no waterproofing was installed at the spandrel beam. Today, one must remove the masonry wall to expose the steel beam for the structural engineer's evaluation and reinforcement (when necessary). Then, the masonry wall needs to be rebuilt with the steel beam waterproofing and a drainage system installation.

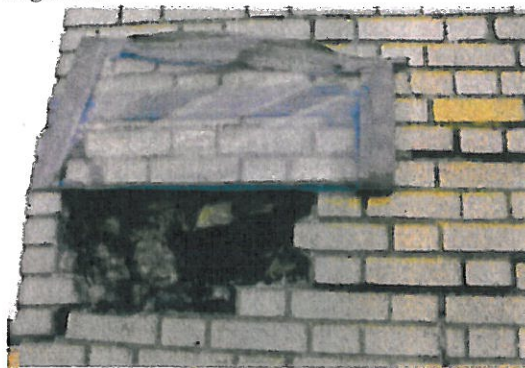
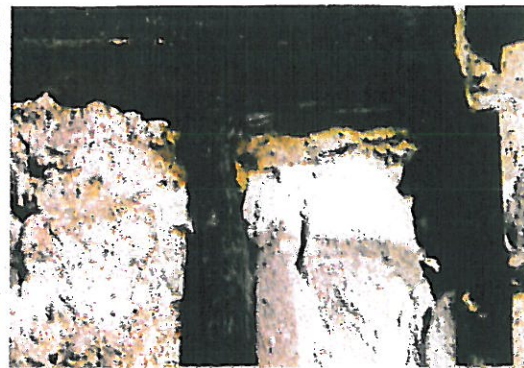
Figure 3

Multiple cracks had developed at the brick parapet wall located at the exterior corner. Cracked masonry was removed from the wall; badly rusted steel beams were observed.

A similar problem can be seen in Figure 3. Multiple cracks had developed at the brick parapet wall located at the exterior corner. Cracked masonry was removed from the wall, and this author observed badly rusted steel beams. About 3.2 mm ( $\frac{1}{8}$  in.) was lost from the steel beam web, given rust expanded eight times. It means rust had expanded for 25 mm (1 in.) and then forced masonry up or out for another 25 mm, developing multiple cracks in the masonry walls.

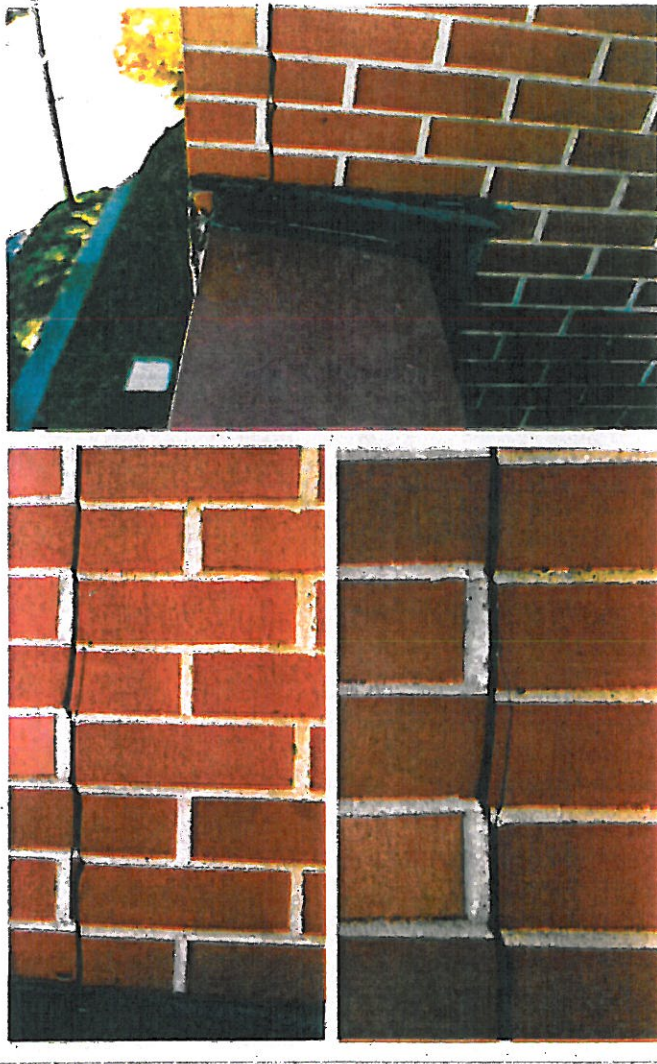
In Figure 4 (page 44), one can see a building that is partially one and two stories. The photo is looking at the 'low roof,' toward the brick veneer exterior corner. A vertical crack had developed in the brick veneer at the corner's roof side, which was located approximately 102 mm (4 in.) from the corner.

This author observed vertical displacement of approximately 4.8 mm ( $\frac{3}{16}$  in.) at this crack.

The problem is the brick veneer located at the roof side of the corner was supported by the roof spandrel beam and did not move. The brick veneer facing the street was supported by foundation 5.5 m (18 ft) below. When the brick veneer facing the street had reached the low roof level, it had irreversible moisture expansion and the thermal expansion, which shifted this part of the brick veneer from foundation up to the low roof level for approximately 4.8 mm.

A vertical crack had developed in the brick veneer at this corner's roof side. Vertical displacement of approximately 4.8 mm (3/16 in.) was noted.

Differential movement of the brick veneer supported by various elements at the different levels had caused this crack. What is the remedy? This vertical crack could be treated as an expansion joint. Brick veneer on each side of the crack became unbraced, and should be anchored to the wall backup system with masonry restoration ties located within 203 mm (8 in.) from the crack on each side of the crack. The crack should be cut straight, and filled with backer rod and sealant.
